Dirt

NEWSLETTER OF EARTH BUILDING ASSOCIATION OF AUSTRALIA Inc

Earth buildings stand out in Black Saturday bushfires

EBAA Inspection of fire affected buildings

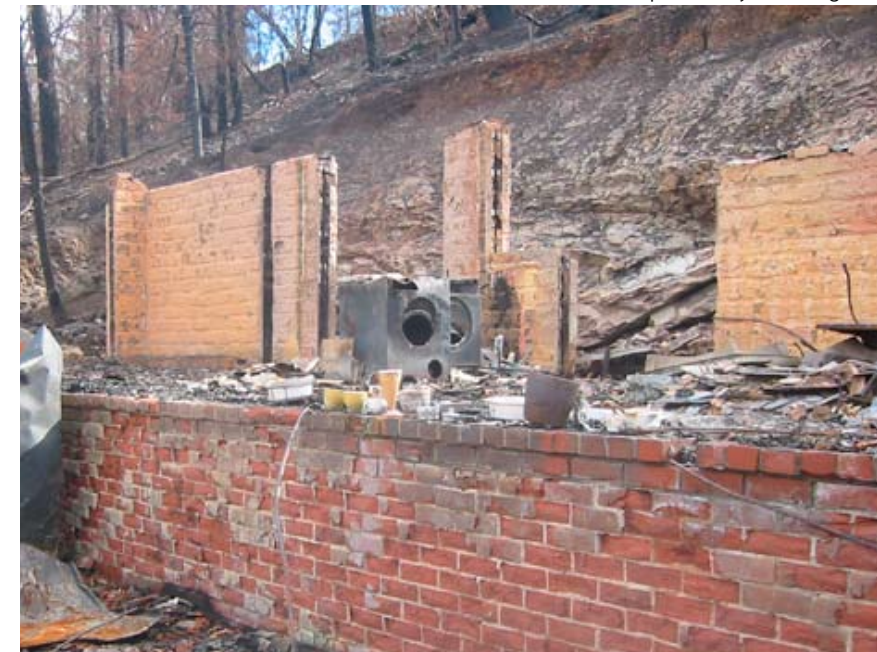
The earth walls of this split level post and beam building remain almost intact with minimum effect on the walls. The photograph shows the rear wall and the split level retainer wall that supports the top slab.

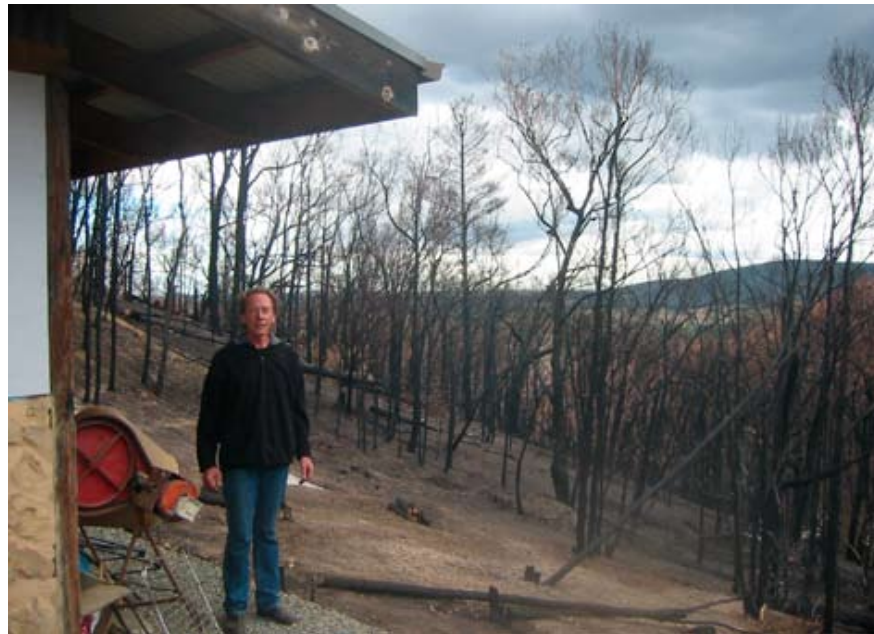
Rob Frie House

Rob Frie's house was one of three that survived in Skyline Road, two were earth houses, the other home being saved by its occupants.

Damage to the house was very limited, slight charring to the fascia and damage to a window frame, plastic pipes and windows.

Rob explained that most of the damage to the house was a result of items having been left close to the wall that had ignited prior to the actual fire front.

The damage to the rear corner post fascia and pipes resulted from a caravan close to the building being destroyed.

Pot plants located around the plastic pipes resulted in the localised damage. Door mats and a dog basket had caught fire and resulted in minimal damage to a low level window frame that had been repaired when the windows were replaced. 13 of the original windows were cracked by the heat with one actually failing and blowing in.

The windows have been replaced since the fire with toughened glass. Attention to detail and good workmanship prevented the ingress of the fire and or embers into the building.

The eave design enabled the roof areas to be sealed preventing the fire entering the roof system. The timber fascia only suffered minor damage despite the house being under attack on two occasions.

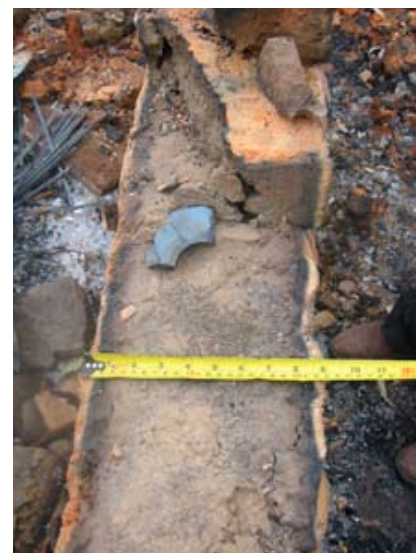
Inspection of a wall section clearly indicates the heat damage to the render coat and the depth of heat moving into the wall.

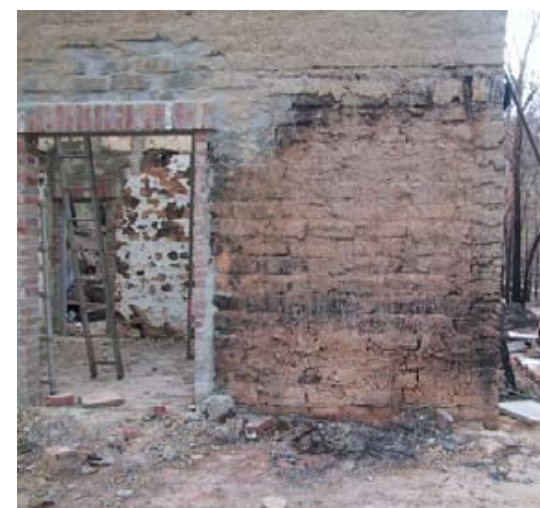
Surface treatment of this earth wall has been damaged by the heat but with minimal impact to the bricks.

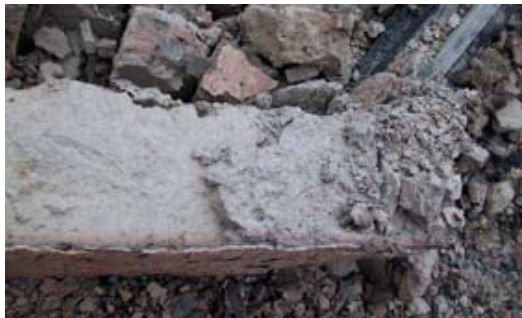
Where a thick cement based render had been applied to earth bricks the render generally suffered severe damage causing the render to break away.

Cement based renders applied to walls that had been constructed from cement stabilized earth bricks had lifted. It was observed that surface failure had occurred akin to concrete cancer where as similar bricks without render had maintained their integrity.

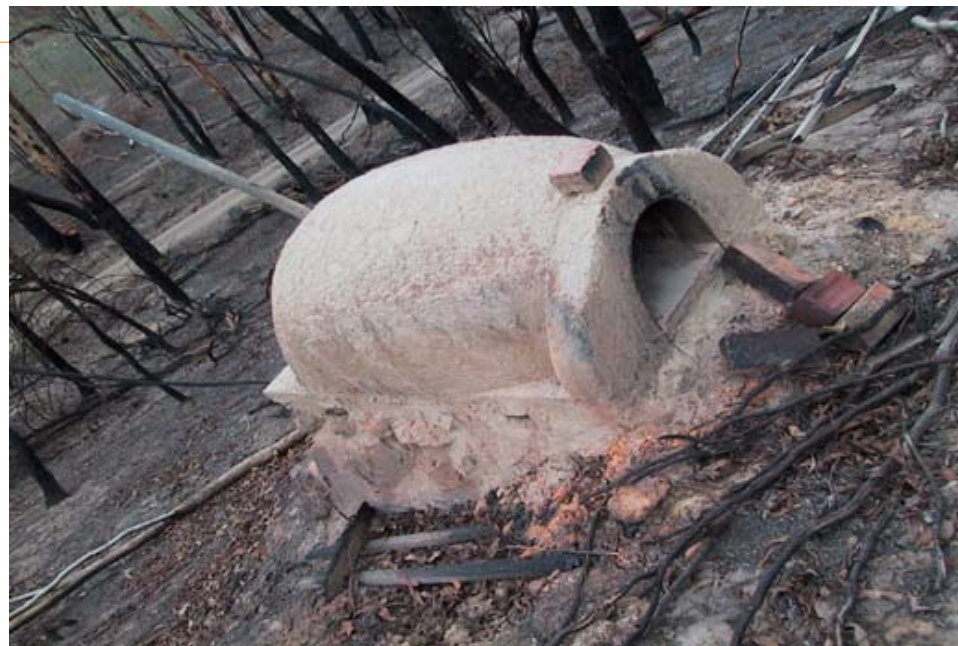
An interesting earth oven that had been formed by forming a frame of black wattle boughs bent and then tied with wire. The frame was covered with newspapers and then covered with a earth mortar mix.. When the oven had dried a fire was lit in the oven burning out the paper and wattle form. The oven survived the fires even though adjacent trees had burnt out the root system deep down into the ground. Fired bricks close by showed considerable deterioration.
