Dirt

NEWSLETTER OF EARTH BUILDING ASSOCIATION OF AUSTRALIA Inc

Earth buildings stand out in Black Saturday bushfires

EBAA Inspection of fire affected buildings

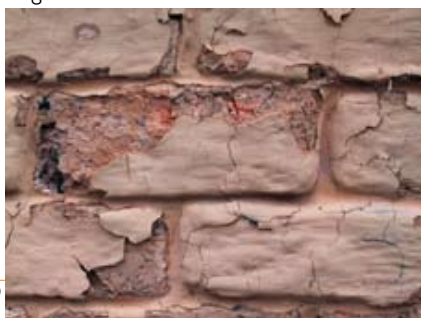
An interesting earth oven that had been formed by forming a frame of black wattle boughs bent and then tied with wire. The frame was covered with newspapers and then covered with a earth mortar mix.. When the oven had dried a fire was lit in the oven burning out the paper and wattle form. The oven survived the fires even though adjacent trees had burnt out the root system deep down into the ground. Fired bricks close by showed considerable deterioration.
